# "Oh Dam" - Bridging the Snake River: A Disclaimer

## **Presentation Overview**

- 1849 Logging Dam-Bridge\*
- 1855 Wood Truss Government Road Bridge
- 1857 Logging Dam-Bridge\*\*
- 1857 Wood Truss Gov't Road Replacement Bridge
- 1861 Logging Dam Bridge
- 1908 Steel Truss Bridge
- 1959 Reinforced Concrete Beam Bridge
- 2024 Reinforced Concrete Beam Bridge

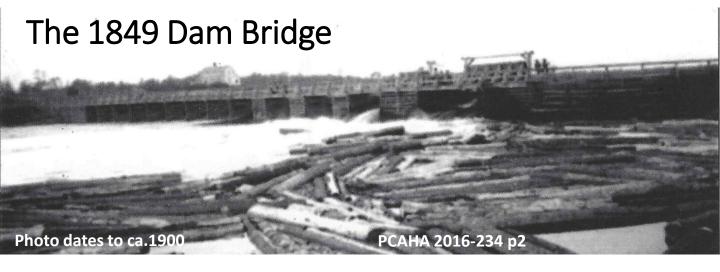
- This photo (ca. 1900) shows the Chengwatana Logging "Dam-Bridge, with sluicing operations in progress with a "tainter" style sluice gate at full open and at least one or more logs having just come through the sluice gate (center of the picture.)

- The builders of the 1849 version of this Dam Bridge did not start out to build a bridge, but to build a dam for logging purposes.
- The bridge itself was a necessary ancillary to the logging dam operation:

- It allowed the dam operators safe and ready access to the entire length of the dam for inspections and maintenance and so that they could add or remove the needed stop logs used to set or adjust the level of impounded water.

- It also gave the operators essential access to quickly open the sluice gates to allow the rapid release of a large volume of water to carry the logs through the gates during sluicing operation. That same flood of water would flush them down the Snake River gorge to the St. Croix valley and from there to the sawmills below at Stillwater and beyond.

- While tainter type sluice gates could be operated by one man (they weren't invented until the 1880s), the first sluice gates on this dam required much more effort to operate, so there was a need for more men to have access.

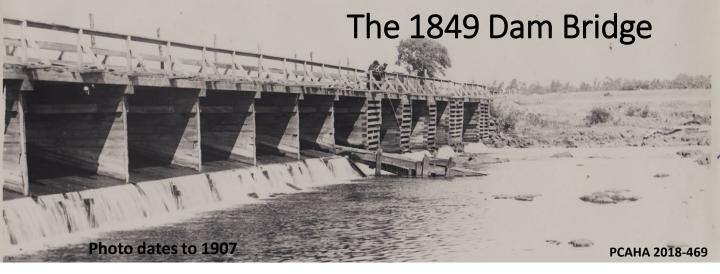
- This photo provides a closer and better look at the details of both the dam and the bridge.
- The log box crib construction, that forms the bridge foundation, is clearly visible on the five northerly piers at the far end of the dam, as is the bridge structure itself.

- At the near end, the crib structure is replaced with a simple wall above the sloped plank floor that covers the box crib structure underneath. Stop logs are set into these openings on the upriver side of the dam. The crib structure is filled with rocks and gravel as ballast.

- The near part the dam is configured as a weir to allow excess water to overflow the top of
  the stop logs without damage to the dam and to keep the impounded water from
  overtopping the dam. Some water flow (leakage) is intentional. Continually wetted wood
  doesn't rot as quickly. Some wood that remains totally wet can last decades or longer.

- In 1908, the Dam-Bridge was surveyed to be 258.6 feet long. The roadway on top was 12 feet wide per 1899 contract between Adolph Munch and the supervisors of Pine City and Chengwatana Towns. This implies the Chengwatana dam structure was at least that deep (upriver to downriver), if not more. A wider dam is stronger & stabler.

- In 1888, Warren Upham reported that the bottom of the sluicegate was at 929.6 feet (asl) and that the top of the dam was at 939.0 feet (asl). The latter height is also interpreted as the maximum height of impounded water that could be achieved (Stop logs installed to that maximum height). The overall structure would be slightly higher.

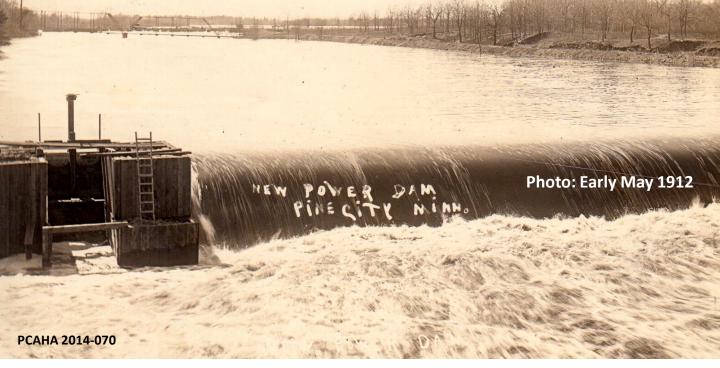
- This photo may seem out of place, it was photographed to show the new 1912 Pine City Power Dam on a post card.
- However, in the background it documents both:
  - The last days in 1912 of the old logging dam, first built in 1849
  - The earliest known photograph of the 1908 high steel truss bridge that replaced it as a bridge. (See enlargement just below) The 1908 bridge will be addressed later.

- We know within days, the date this photographed was taken (early May 1912) based on the following:.
  - It shows the power dam which had just been built in a six week period during February and March, 1912.

- The gates of the **old logging dam** were opened wide (in compliance with the court order) on April 1<sup>st</sup>, 1912
  - On May 12, the local newspaper reported that water levels near the 1908 bridge was nearly touching the bridge planks at the north end of the bridge

- This appears to be confirmed by this photo (see enlargement) by the nearness of the water below the bridge planks at the far right of the bridge.
- Likewise, beyond the 1908 steel truss bridge, the **old logging dam** can still be seen in the background with all its gates apparently wide open given the turbulence of the water.

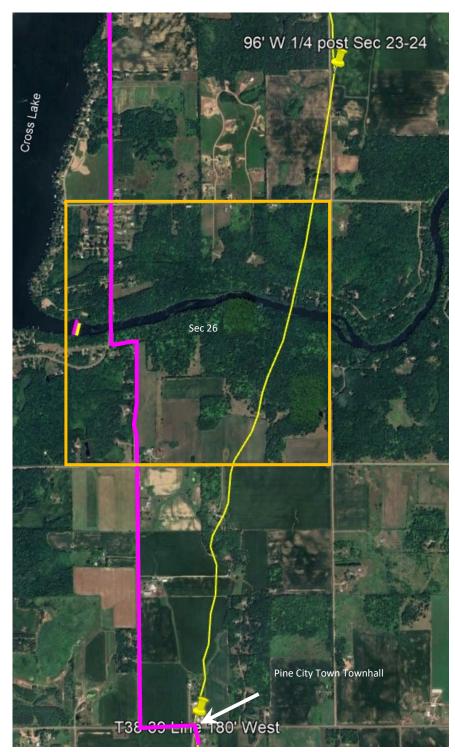
Google Earth Imagery obtain on 03-14-2024 showing Logging Dam,
Government Road and Area

- This a Google Earth image of the region east Cross Lake with Section 26 where Grover Singley locates it outlined in orange.
- The Magenta line shows the current Government Road alignment, but this location is not the original alignment.
- We have to ask the question, "Where did the road cross the river in 1855?"
- I believe one likely answer is found in the original Field Notes for the 1857 Government final survey of the road to document what was actually built.
- The light yellow line is a plot of that Field Note data.
- The 1855 bridge location should be where it crosses the Snake River.
- Unfortunately, the only two places on this line are precisely known. They are at the "stick pins" at the top and bottom.
- At these points, the surveyor noted the road's location relative to the 1851 Public Land Survey sectional monuments in his field notes.

In between these two points, NO point on the line is very far from the actual surveyed route, we just don't know its exact location like we do the two end points. The actual route may drift right or left of the portrayed line by a matter of feet or yards. It could be as much as several hundred feet, but it CANNOT be much further than that, if at all, for it to connect to the two known points at either end and still be consistent with the recorded survey data.

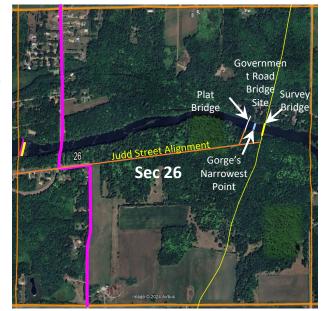
CHENGWATANA Government Bridge -Lots 14 & 15 MHS G 4144 .C487 1857 .P39 6F Chengwatana Plat - Ca. 1856-7

- The Chengwatana Plat (right), also provides a likely location for the Government Road Bridge
- Initially, we were unsure of how to relate this plat to modern maps so we could accurately identify the bridge location.
- That dilemma began to be resolved with the discovery of selected Chengwatana plat details that had been replicated in two separate Pine County Auditor records.
- These Subdivision plat records for section 26 & 27. recorded the physical location and size of Blocks

170, 162 & 163, as well as lots 14&15 in Blk 163 relative to specific locations & monuments on the mutual Public Land Survey boundary between sections 26 & 27.

- With this information, the plat can be located and properly oriented to accurately transfer the plat's location for the Government Road Bridge to modern maps. It is shown as the white line.

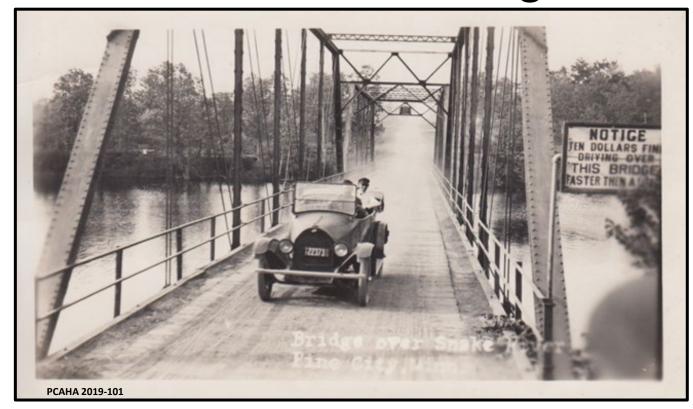
## The 1908 Steel Truss Bridge

- The building of the 1908 Steel Truss Bridge was the culmination of many other events.
- For many years from 1861 to the 1908, the only bridge across the Snake River was a bridge built on top of the logging dam, but it was a point of controversy and was the subject of lawsuits to remove it almost from the beginning.

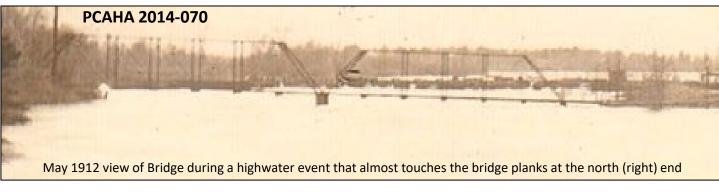
Two views of the 1908 High Steel Truss Bridge showing the incline from north to south

- The site was approximately 720 feet downstream from the logging dam and 750 feet below today's dam.
- It had three spans (124' south, 100' mid, 16' north) with an overall length of 240 feet and roadway width of 17'.

- The south truss had a chord height of 20 feet and the mid river truss had a height of 18 feet. Both spans were a "Pratt Truss" configuration. The 16' north span was as simple beam configuration using 12" timber stringers.

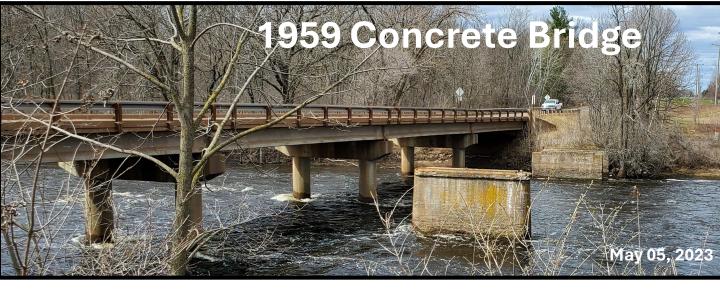
- Construction of the substructure began in 1958 before winter set in with the superstructure being completed during the summer of 1959.
- The road approach from the south to the new bridge was changed to eliminate a hard turn at the bridge for CSH 9 traffic from both directions

- The 285 foot bridge crossed the river with 5 spans of prestressed concrete beams.
- In turn, the beams were supported on four concrete piers and two end abutments

- The 24 foot wide deck was also constructed of steel reinforced concrete.
- This bridge had been constructed about 40 feet upstream from the 1908 bridge so that the old bridge could be used for traffic while the new one was completed.

- Two piers and the north abutment for the 1908 bridge are visible just downstream from the 1959 bridge.
- If you looked while driving, the latter could be seen from the northbound lane.

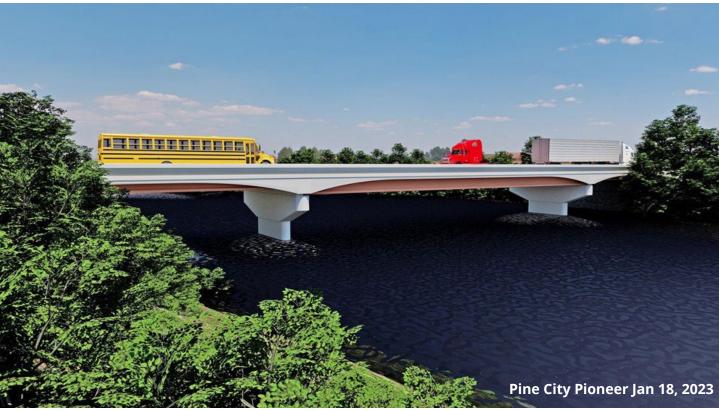
This is a rendering of what the new bridge will look like when it is completed in 2024

- The new bridge is expected to last 100 plus years and will be a similar structure with prestressed concrete beams and substructures
- The roadway surface will be forty feet wide with two traffic lanes, each 12 feet wide, as well as an eight foot shoulder on each side.

- Two 18" thick by 36" high guardrails will be added to the roadway for a total width of 43 feet.
- The traffic lanes and shoulders are separated by painted striping.

- When completed, the new bridge will be 298 feet end to end.
- Instead of five spans like its predecessor, the new bridge will employ three spans supported by two in river piers and two end abutments.

- The two in-river piers are 135 feet apart center to center. In turn, each pier center is 81.5 feet from the outside of their respective end bridge abutment

- The eight prestressed center beams are each 54" deep, 135' long, and weigh 112,000 lbs.
- The ten (five each side) side span prestressed concrete beams are 36" deep and 80 feet long.

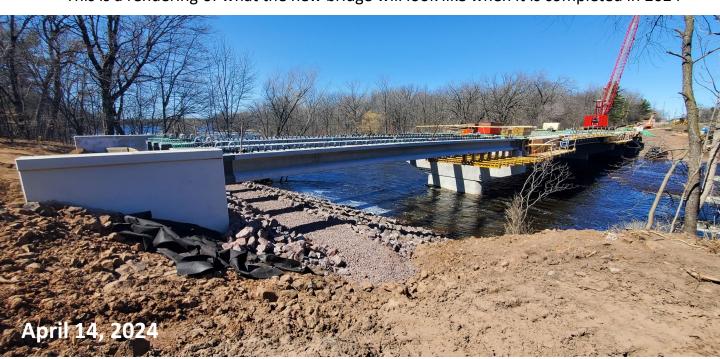
Since construction began in early December, significant progress has been made to advance the work to eliminate the need for "in river work" ahead of the April 15<sup>th</sup> permit deadline and to allow the most other work to continue.
